GENERAL DYNAMICS | CONVAIR

Report No. 8926-094

Material - Finishes and Coatings - Wear Resistant

Abrasion Resistance

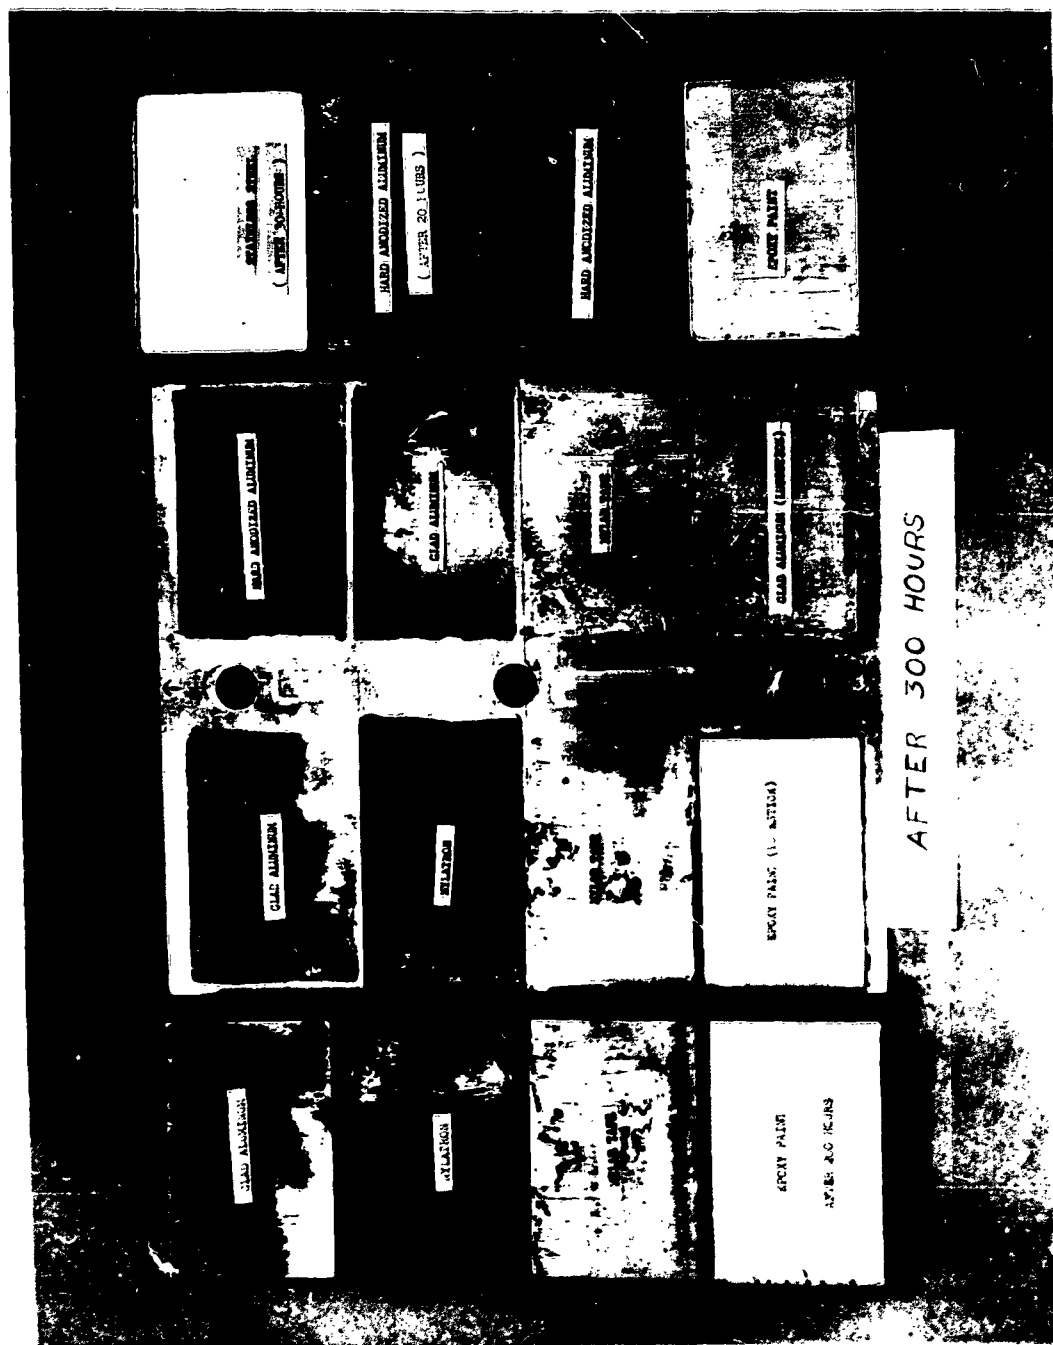
FIGURE 8

CONDITION AFTER 300 HOURS

The faying surface joints were dis-assembled periodically for inspection. Photographs of the faying surfaces were taken after 20, 100, 200, and 300 hours of testing. These photographs are shown in Figures 2 thru 9. Each hour of testing represents 51,000 cycles. Tests were stopped after 300 hours (15,300,000 cycles).

Results are listed in Table II. Conditions of the faying surfaces are shown in Figures 2. through 9. The Figure numbers and positions shown in Table II refer to the location of the most severe condition of wear for each faying surface combination in the Figures. Positions in the Figures are numbered from top to bottom and left to right as follows:

| Faying Surface No. | Hours Tested | Comments | Ref. Fig. No. & Position | Relative Rating |
|---|---|---|---|---|
| 1 | 210 | Control-discontinued after 210 hours because of severe galling | Fig. 8 Pos. 1 | Poor |
| 2 | 300 | Good abrasion resistance but not as easily installed as faying surface No. 13 | Fig. 8 Pos. 2 | Good |
| 3 | 300 | Same as above | Fig. 8 Pos. 3 | Good |
| 7 | 300 | No advantage over faying surface No. 15 | Fig. 8 Pos. 7 | Good |
| 8 | 300 | Protected aluminum but may not be practical to keep surface lubricated | Fig. 8 Pos. 8 | Good |
| 9 | 200 | Same as above | Fig. 8 Pos. 4 | Good |
